Reserve Fund Analysis Report – Level 1

**Kissing Camels POA
Colorado Springs, CO**

Report #: 8922
For Fiscal Year 2014
Beginning: July 1, 2014
Ending: June 30, 2015
Date Prepared: February 19, 2014
Prepared by: Richard Hamilton, RS

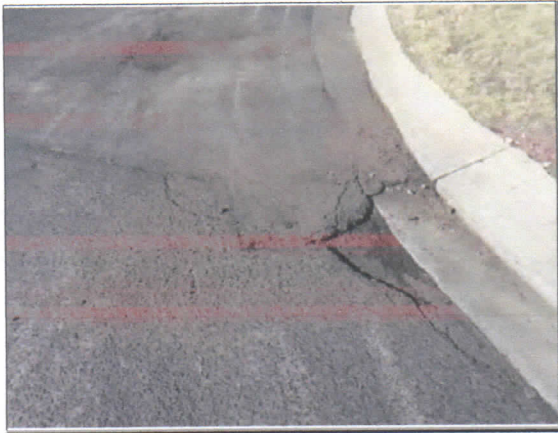
Comp #: 201 Asphalt - Resurface

The roads vary in condition ranging from good to fair. We have established a rotation of replacement addressing 33% of the roads every 7 years, so that all roads are replaced every 21 years.

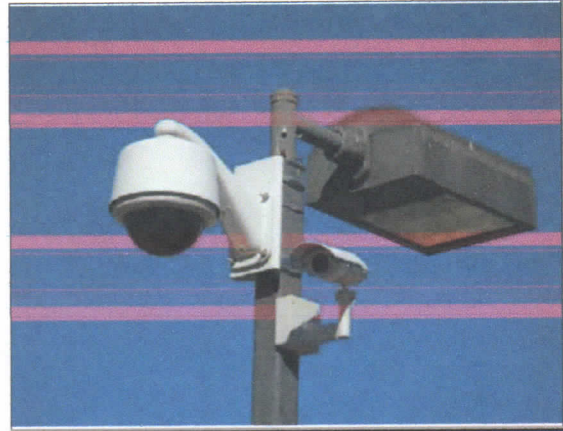
Comp #: 720 Security System - Replace

The security system consists of cameras, monitors, encoders and recorders, as well as several servers. System was reported to have been replaced in 2011. Anticipate future replacements due to age and changes in technologies.

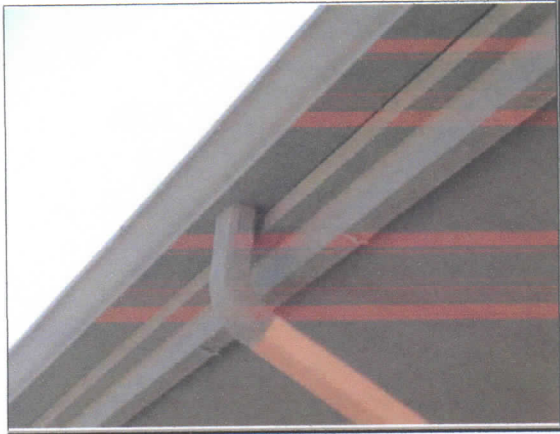
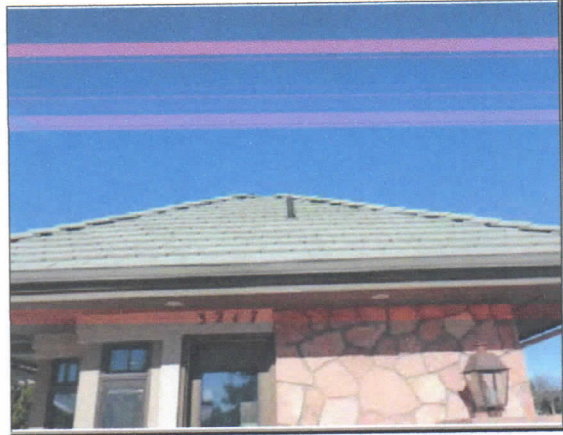
Comp #: 1315 Gutters/Downspouts - Replace

Gutters and downspouts are in overall good condition. Recommend yearly inspections to ensure gutters and downspouts are clean, and repair any leaks or damaged areas. Proper water flow is important to mitigating any fascia damage and ensuring water is directed away from the foundation.
