Photographic Inventory Assessment

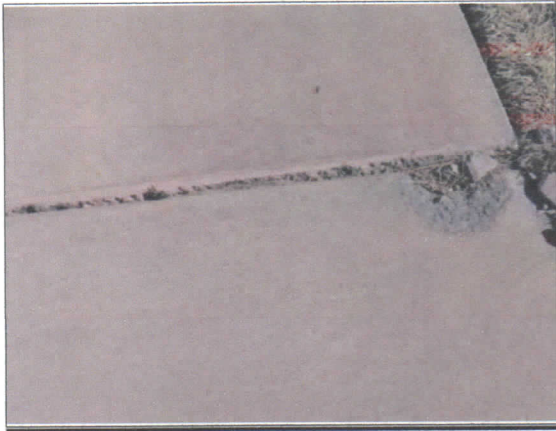
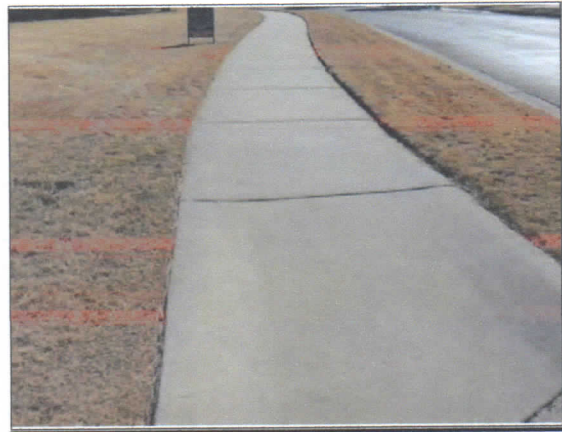
Comp #: 103 Concrete Walks - Replace

Concrete is in good condition with minimal areas of cracking or deterioration observed. Concrete should be inspected periodically and cracks sealed to prevent moisture penetration. Moisture penetration will cause concrete to heave and break. Cycle work with other concrete projects when possible, for economic efficiency.

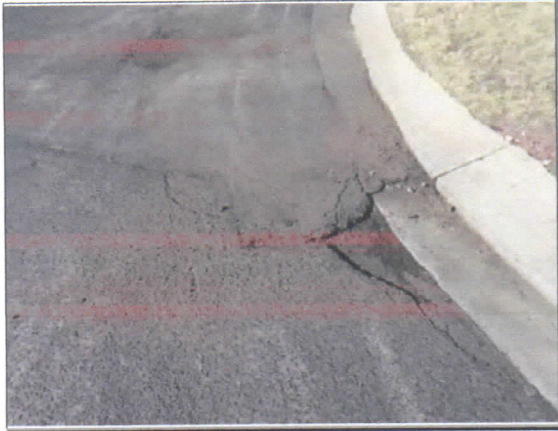
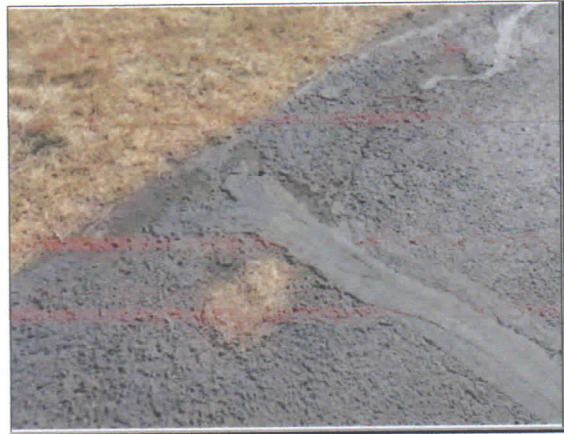
Comp #: 201 Asphalt - Resurface

Asphalt ranges from good to poor condition with areas of filling, patching and damage noted. Recommend yearly inspections to ensure surface integrity and fill any developing cracks. Also, shoulder design and maintenance are critical in maintaining the integrity of the asphalt in areas where the edges are not supported by a curb system. We recommend following CDOT road design (cross section) recommendations, or engage an engineer to recommend specific design criteria for this community. Funding anticipates resurfacing approximately 30% of the community per cycle, addressing the entire community over a 20 year period.

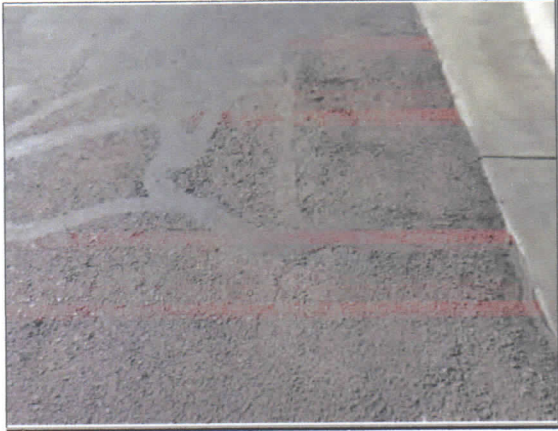
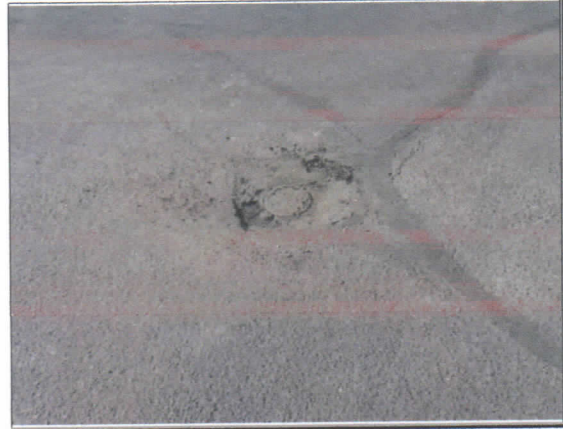
Comp #: 202 Asphalt - Seal/Repair

Scratches, raveling, loss of coat, UV damage

Asphalt surface ranges from good to poor condition. Seal coating does not add any structural integrity to the asphalt. However, seal coating protects the asphalt from UV deterioration and fills cracks typically no larger than 1/16". Recommend yearly inspections and crack/fill work to mitigate any subsurface moisture. Funding anticipates sealing approximately 25% of the community annually, so that the entire community is sealed every 4 years.

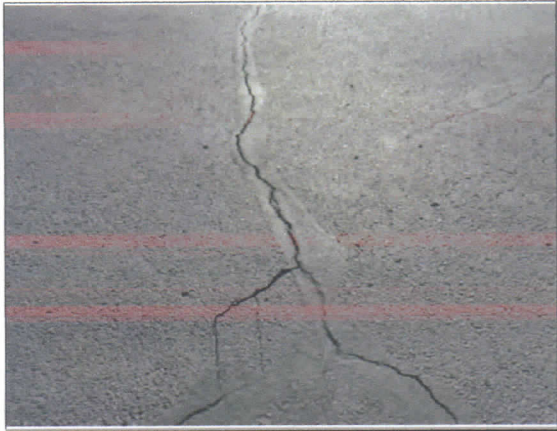
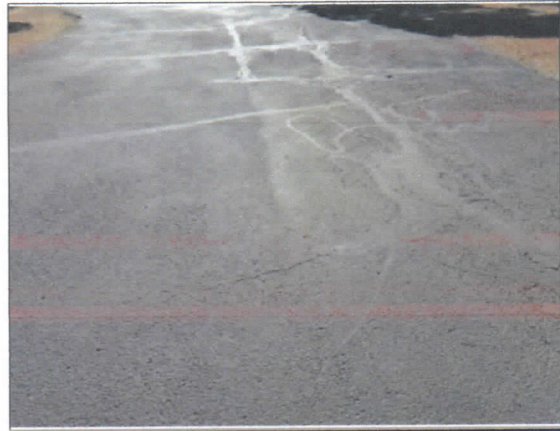
Comp #: 202 Asphalt - Crack Fill

Cracking near manhole covers, some edge cracking

Recommend yearly inspections and crack/fill work to mitigate any subsurface moisture. Subsurface moisture and loads typically contribute to accelerated deterioration. Also, timing is important in when scheduling crack/fill work to be completed in order to take advantage of maximum shrinkage and workability of materials during the warmer months of the year.

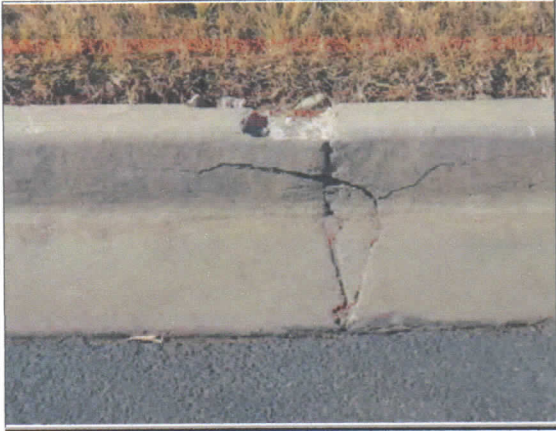
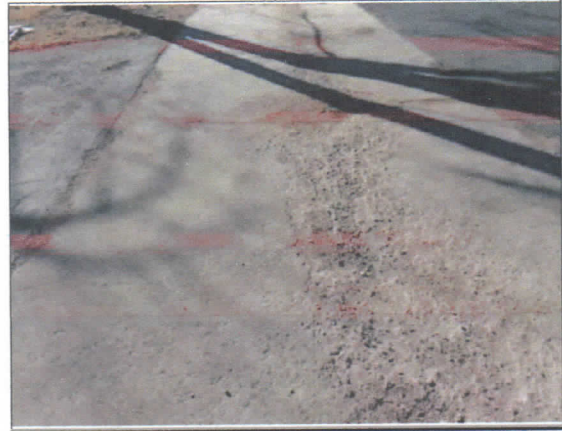
Comp #: 204 Concrete Curb & Gutter - Replace

Some settling cracks, some chips and freeze damage. All minimal.

Concrete curb and gutter range from overall good to fair condition with isolated areas of cracks and chipped concrete. Repair and replace curb and gutter to mitigate any subsurface moisture. Cycle work with other concrete projects when possible, for economic efficiency.

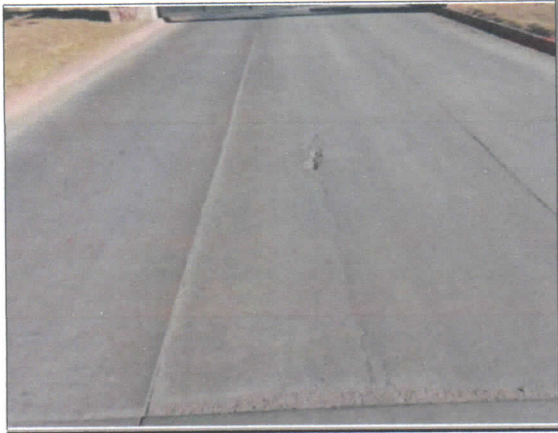
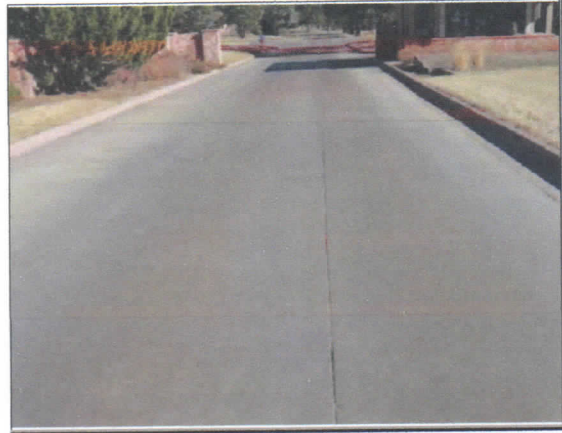
Comp #: 205 Concrete Drive - Repair

Some limited settling, one cracked section

Concrete located at the entrance area is in overall fair condition with some signs of cracking and settlement. Recommend repairing trip and fall hazards immediately and inspect yearly for any ongoing damage. Also, recommend repairing and replacing concrete to mitigate subsurface moisture penetration, which will accelerate the useful life of this component. Cycle work with other concrete projects when possible, for economic efficiency.

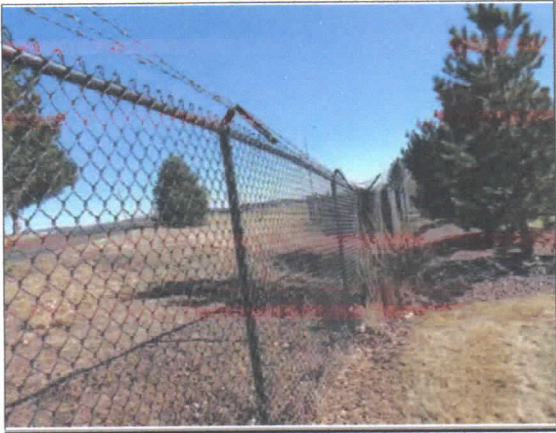
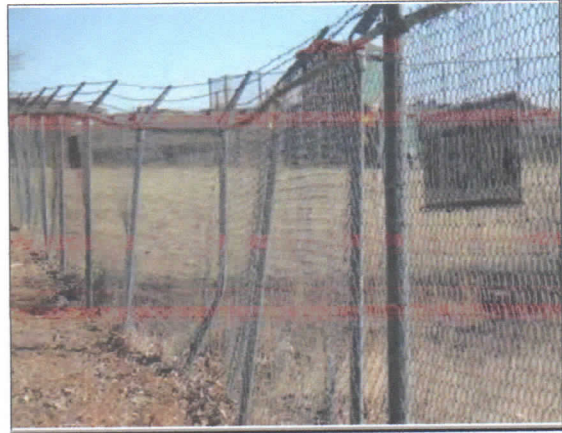
Comp #: 502 Chain Link Fence - Replace

Evidence of persons climbing over fence near east edge adjoining office park.

Chain link fencing varies in age and condition, but is in overall good to fair condition, with some damage noted near the high school area. Recommend stretching and tightening fence between major replacement cycles to maintain integrity. Replacement anticipates reusing a majority of the poles when possible.

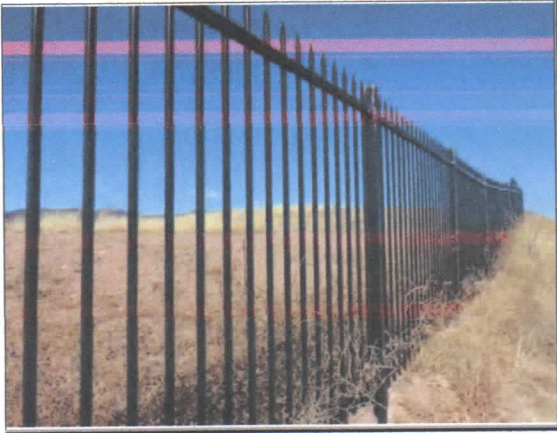
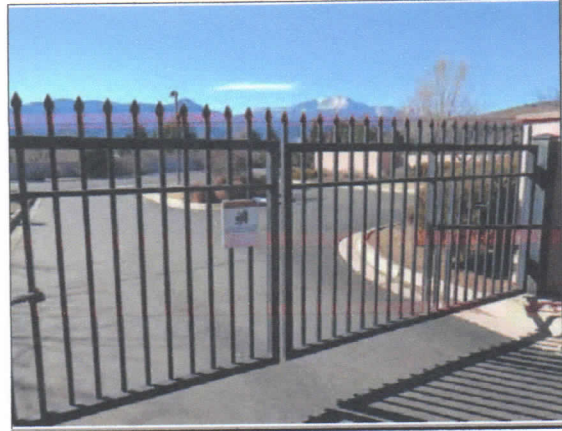
Comp #: 503 Metal Fence - Replace

Surface is intact, general fading overall.
Appears to be Amstar.

Metal fence is in good condition with no significant signs of rust or damage, but significant fading in areas. Recommend maintaining fence by ensuring paint and surface integrity are intact. Treat rust prior to painting. Funding is to replace fence due to age, wear and exposure to the elements.

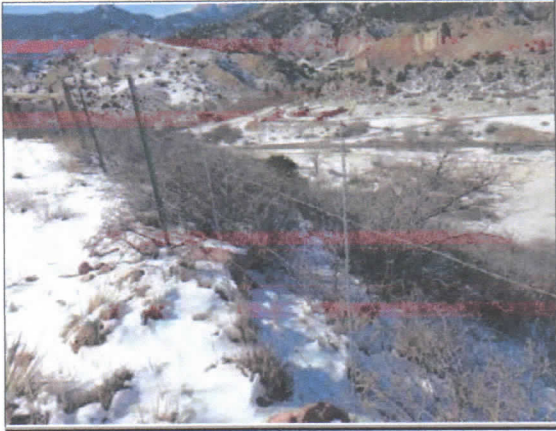
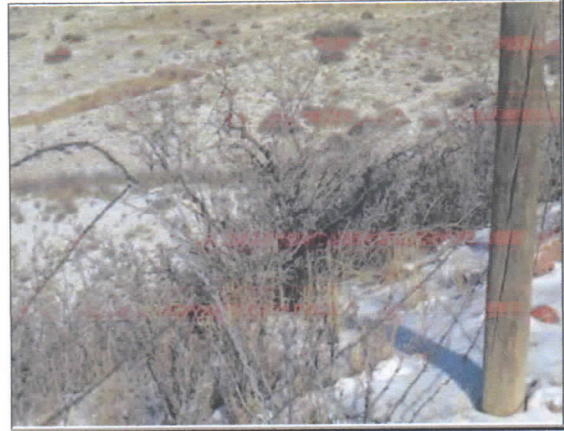
Comp #: 506 Wire Fence - Replace

Wire fencing with a combination of metal and wood posts. Typically \$2.00 LF to fully replace depending upon access.

The wire livestock fence is in overall fair condition. Funding is for ongoing repairs and replacement on an as-needed basis. The entire fence was not closely inspected due to access limitations.

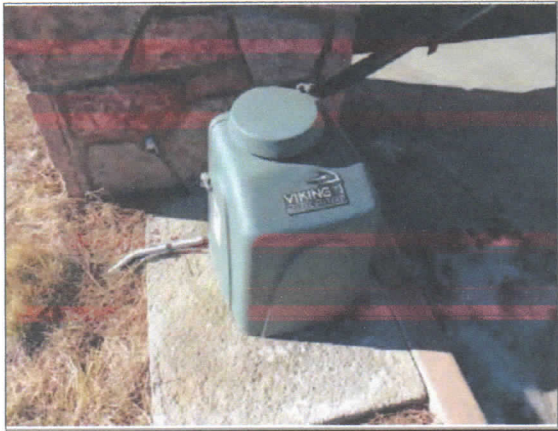
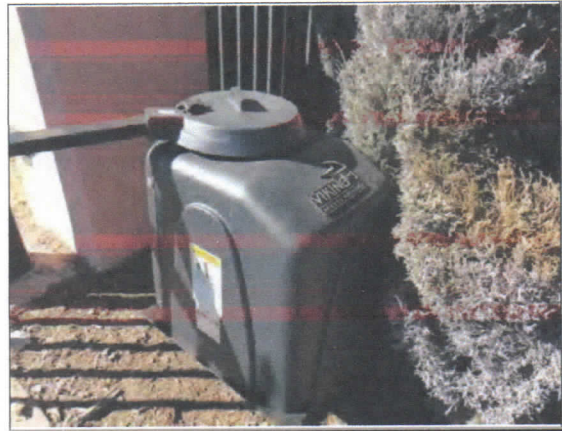
Comp #: 705 Gate Operator - Replace

Main entrance - (2) Viking F-1 installed 2008
North entrance - (4) Elite CSN-200-UL installed 2004
West entrance - (4) Viking F-1, (3) installed 2004, (1) replaced 2013

Gate operators are reported to be operating properly, with 1 replacement noted. Recommend regular inspections, cleaning and maintenance to ensure useful life. Funding anticipates replacing operators on an as-needed basis with no anticipation of replacing all operators at one time.

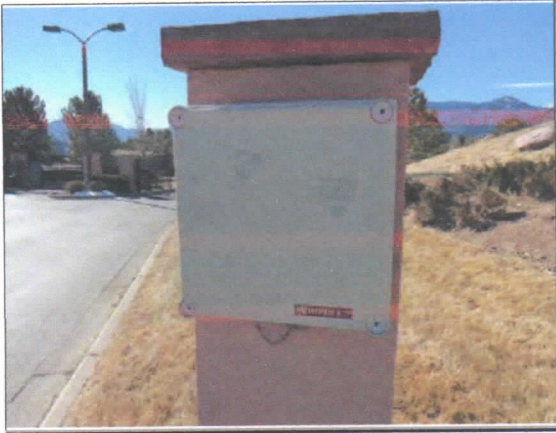
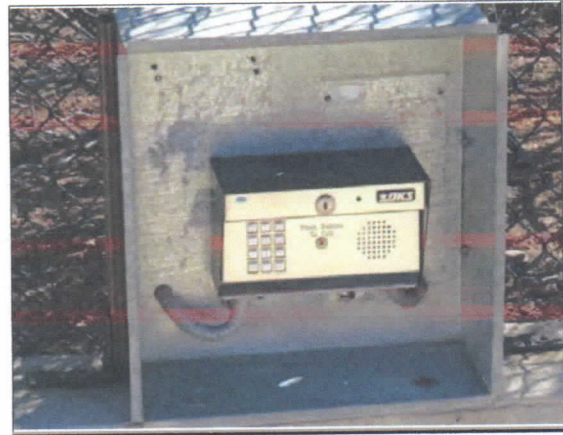
Card/Keyless Entry System - Replace

Keyless entry system at gate areas are operating and in overall good condition. Allowance is to upgrade system due to ongoing technology advances.

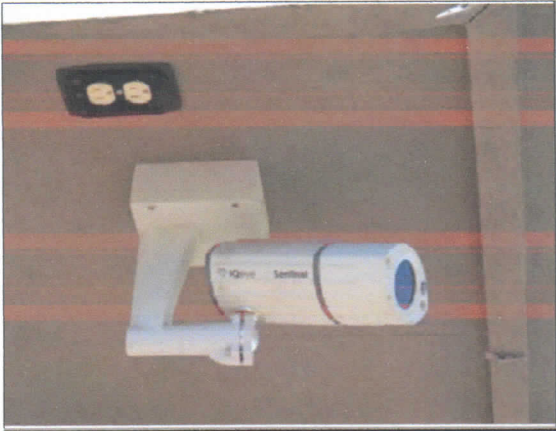
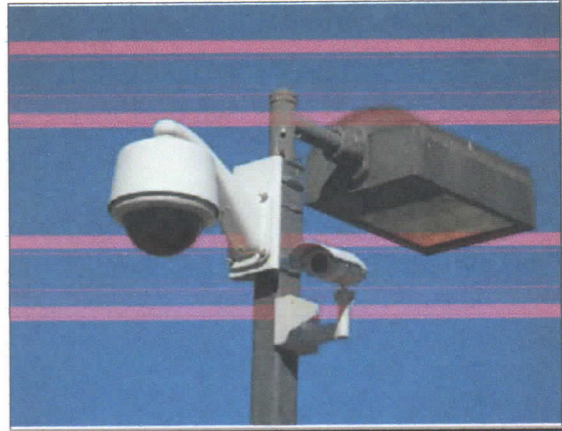
Comp #: 720 Security System - Replace

The security system consists of cameras, monitors, encoders and recorders, as well as several servers. System was reported to have been replaced in 2011. Anticipate future replacements due to age and changes in technologies.

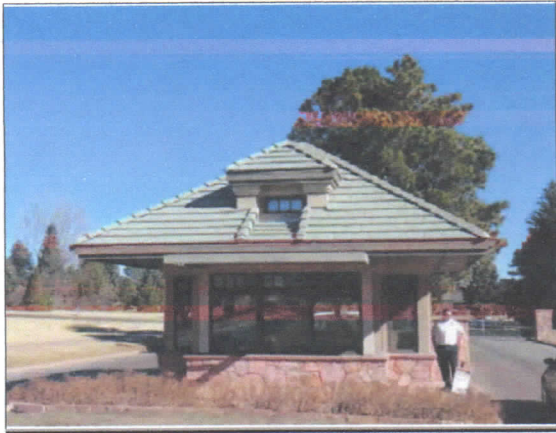
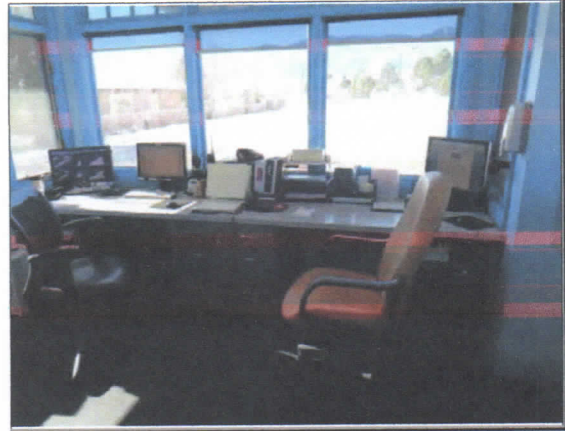
Guardhouse - Refurbish

Guardhouse is in overall fair condition, but in need of trim paint. Interior is finished with basic carpet and paint, desk areas, a restroom and small HVAC system. Funding is to refurbish the interior due to age and use. Typically clients do not see the interior of this unit, therefore the level of funding is solely at the discretion of the Board.

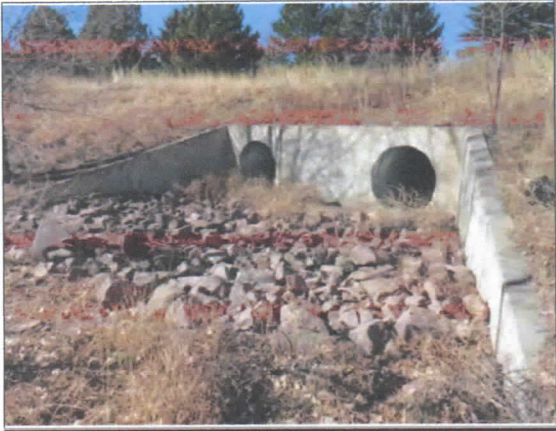
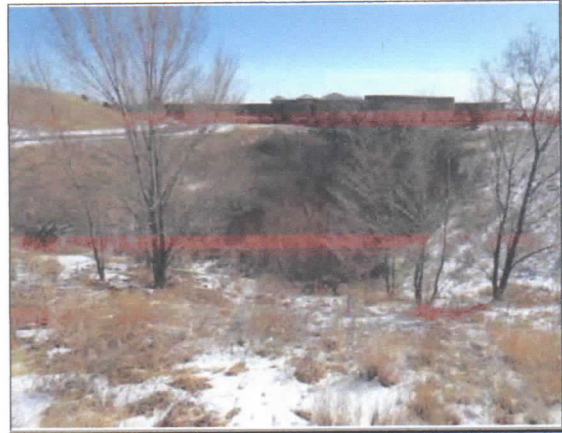
Comp #: 1022 Drainage Detention Areas - Clean And Maintain

Lower area has extensive growth, outlet needs cleaning.

Approximately (2) water detention areas serve the community. Pond areas range from small vegetative areas to larger grassy areas with minimal concrete pans. Funding is to clean outlets and mow vegetation and make periodic repairs to concrete. Regular cleaning is necessary to ensure proper function.

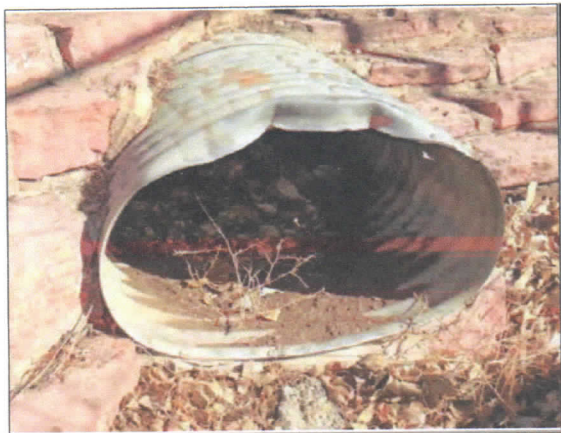
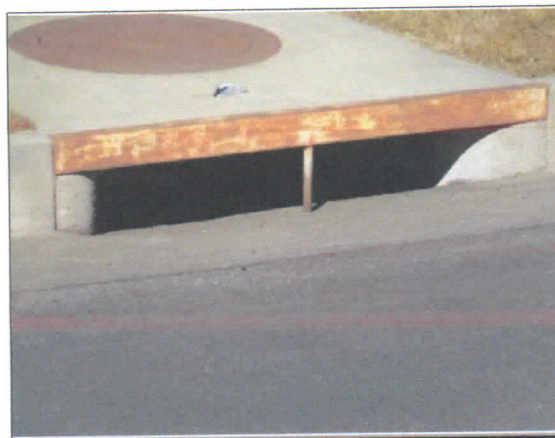
Comp #: 1022 Drainage Underdrains - Clean And Maintain

Periodic cleaning of the drainage system is critical in managing proper water flow and control. Regular maintenance includes cleaning, cleaning screens and removing sediment from receiving and tail ditches where necessary to maintain flow lines. We also recommend regular inspection of the drainage pipes to ensure debris removal and proper flow. It is reported that the community recently completed a major cleaning project.

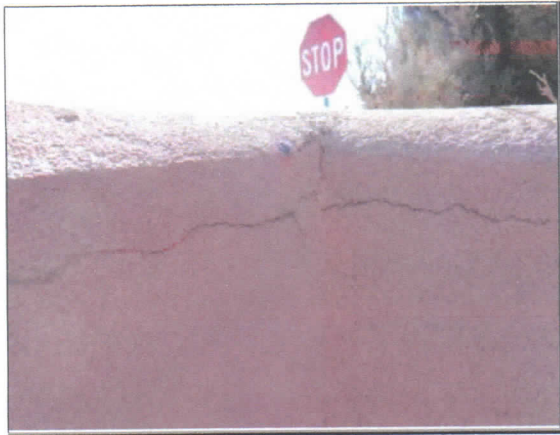
Comp #: 1105 Stucco Wall - Repair

Minor cracking observed. Several near west entrance area. Replacement typically runs \$100 - \$110 LF

The 5 foot wall is finished in a stucco material over a block base. Stucco is in overall good to fair condition with areas of cracking and flaking stucco particularly at the joints and crowns. Recommend yearly inspections to ensure surface is intact and any noted cracks are caulked properly. Surface integrity is critical in ensuring the useful life of this component.

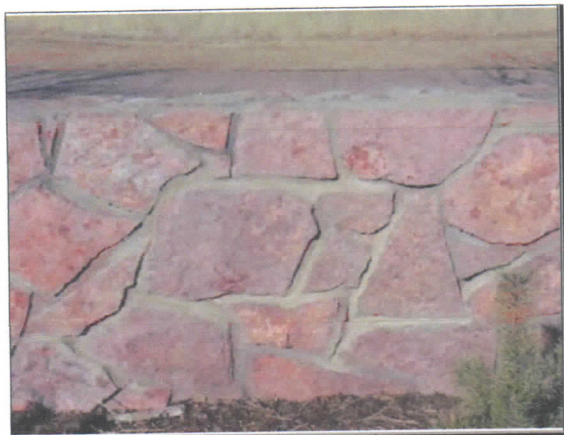
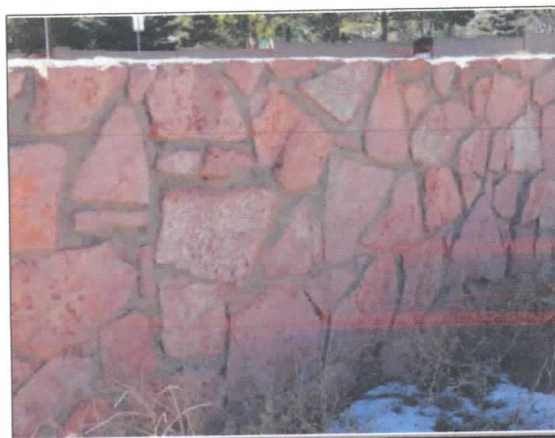
Comp #: 1105 Stone Wall - Repair/Repoint

Many signs of repair and repointing throughout.

Stacked stone wall is in overall good condition exhibiting signs of recent repointing and repairs. Funding anticipates a continued program of repairs as necessary, with no anticipation of replacing entire wall at one time.

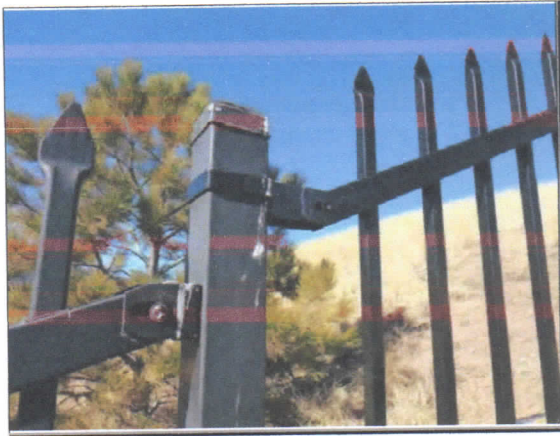
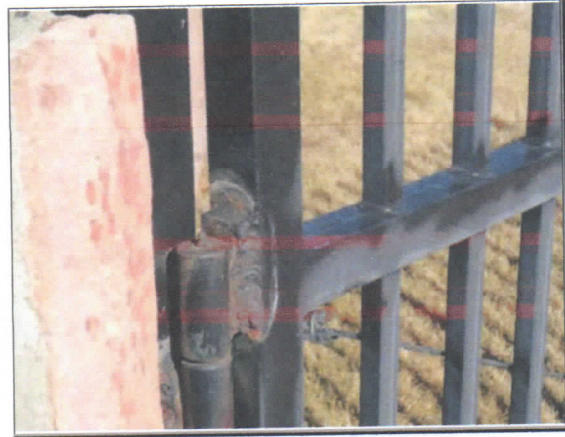
Comp #: 1107 Metal Fence - Repaint

New sections noted. General fading overall, but surface is still intact.
Old fence = 1,200 LF
New areas = 1,300 LF

Metal fence is in good condition with no significant signs of rust or damage, but significant fading in areas. Metal surfaces have a powder coated finish that, once damaged, will require restoring and protecting surface from moisture. Due to prohibitive costs of removing fence to re-powder coat, funding anticipates regular cycles of paint, utilizing a high quality exterior metal surface product.

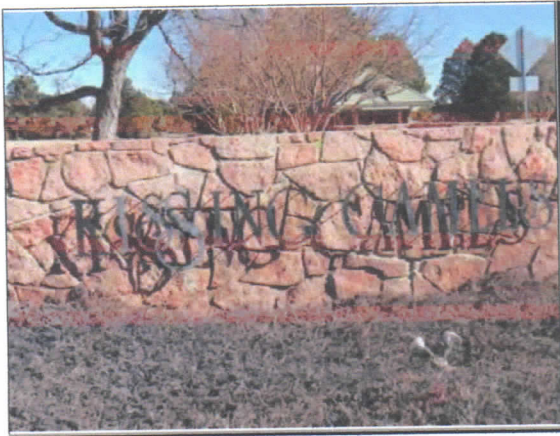
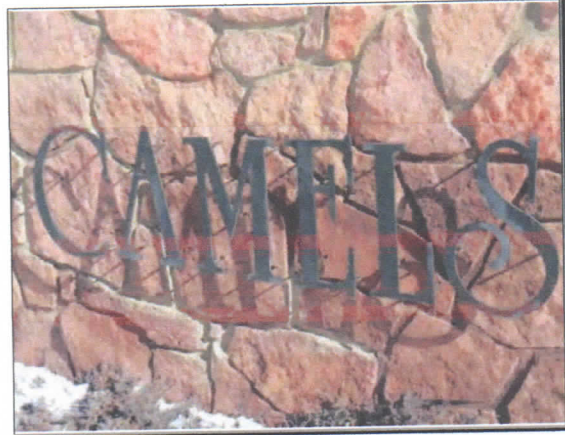
Comp #: 1150 Monument Signage - Refurbish

The metal monument signs are mounted to the stone wall, and appear in overall good condition. Funding anticipates refurbishing on a regular basis, including rust treatment and repainting, along with any necessary repairs. No anticipation of replacing signs.

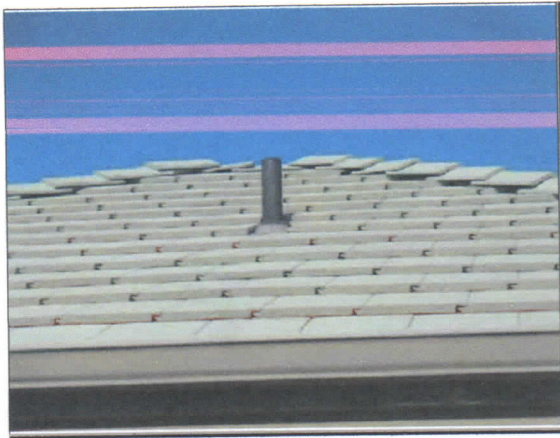
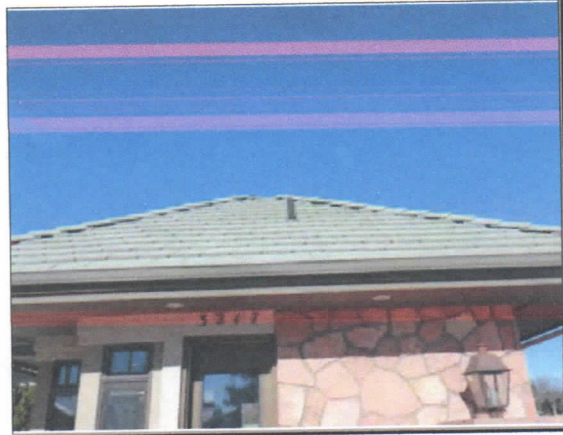
Comp #: 1304 Tile Roof - Replace

No noted chips, cracks or broken tiles. Costs a little higher due to small quantity.

Tile roof appears in overall good condition. Recommend annual roofing inspections with close attention to areas of roof that may permit water intrusion such as valley areas and penetrations. Underlayment deterioration caused by exposure to sun for a long period of time prior to tile installation, dirt build up on batten boards trapping water and moisture can cause rapid deterioration by removing the oils on the asphalt underlayment. Funding anticipates eventual replacement due to underlayment concerns.

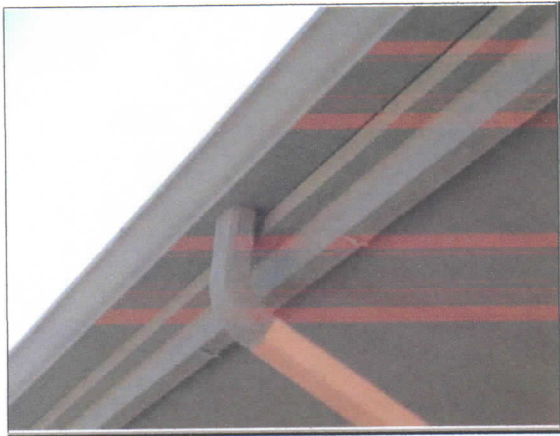
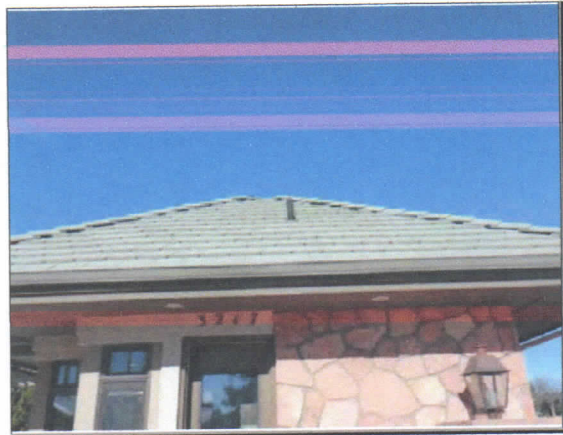
Comp #: 1315 Gutters/Downspouts - Replace

Gutters and downspouts are in overall good condition. Recommend yearly inspections to ensure gutters and downspouts are clean, and repair any leaks or damaged areas. Proper water flow is important to mitigating any fascia damage and ensuring water is directed away from the foundation.

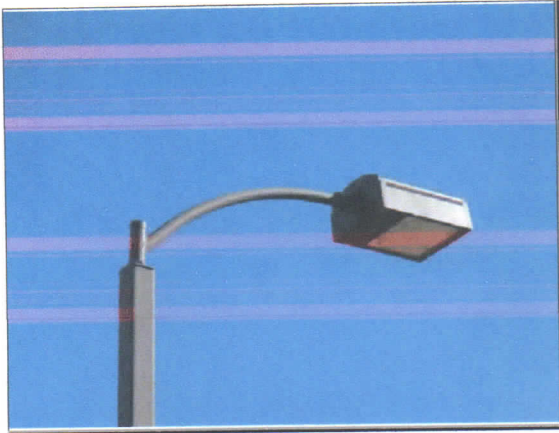
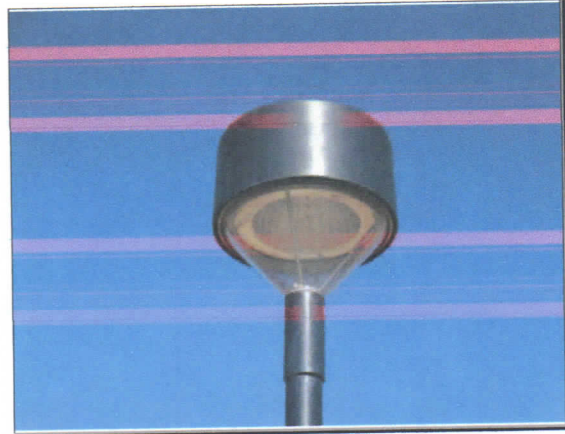
Comp #: 1501 Pole Lights - Replace

Most have slight rusting at concrete base attachment.

Poles appear in good condition with limited base rusting, but no noted damage. Recommend poles be inspected and maintained by painting on a regular basis. Funding is to replace fixtures, poles and underground wiring due to changes in technologies and efficiencies.

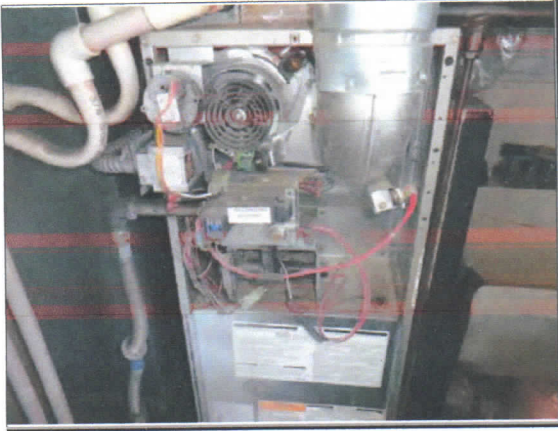
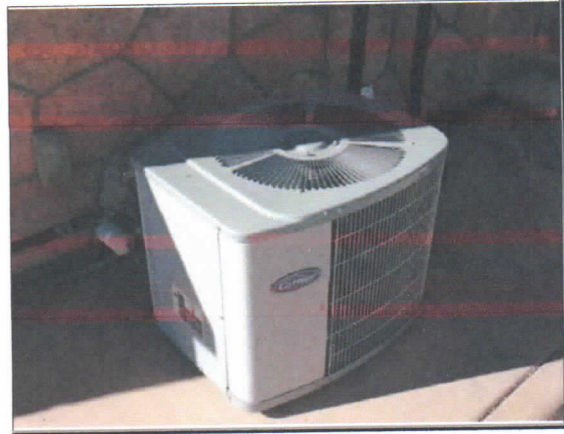
Comp #: 2520 HVAC System - Replace

The Carrier HVAC system, model #68STA045 and air conditioning condenser, model #38TK3024300 appears older and has received some damage to the top of the enclosure. Recommend regular inspections and service by a qualified air conditioning technician.
