Photographic Inventory Assessment

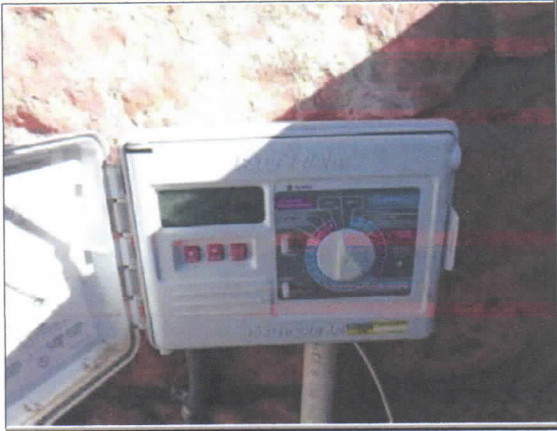
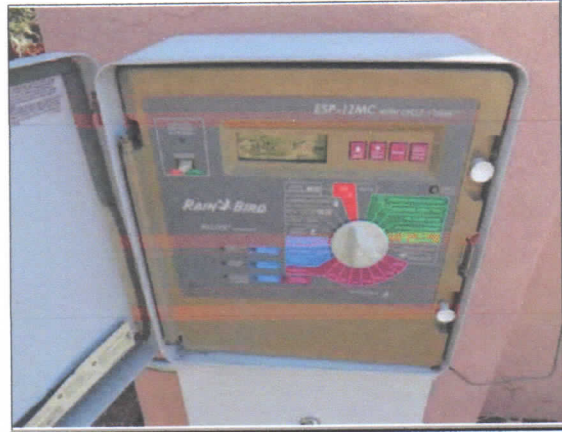
Comp #: 1003 Irrigation System - Replace

The irrigation system is assumed to be in functional operating condition with no significant problems reported. As routine maintenance, inspect regularly, test system, repair as needed from operating budget. Follow proper winterization and spring start up procedures. If properly installed and bedded without defect, the elements within this component are generally low cost and have a failure rate that is difficult to predict. Best suited to be handled through the operating budget. No basis for reserve funding at this time.

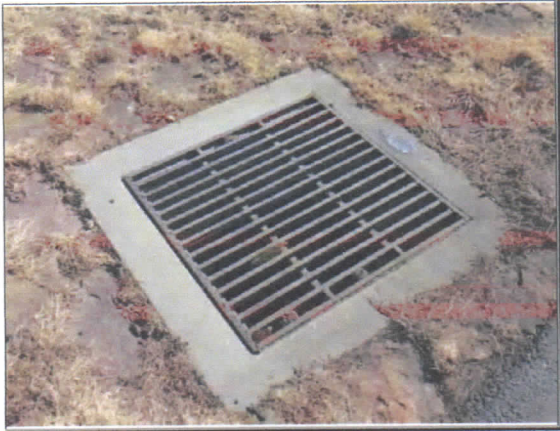
Comp #: 1022 Drainage Basins - Clean And Maintain

Drainage basins provide entry points to the underdrain system. Funding for cleaning the entry and exit points is included in component #1022 Drainage Underdrains - Clean and Maintain.
